MTS DOES NOT ENDORSE THE ABOVE LINKS, ANGELFIRE ADDED THIS
ICOM 211/245(S)/251/451/701

The most common problem is bad solder connections in the PLL unit and Display driver unit.

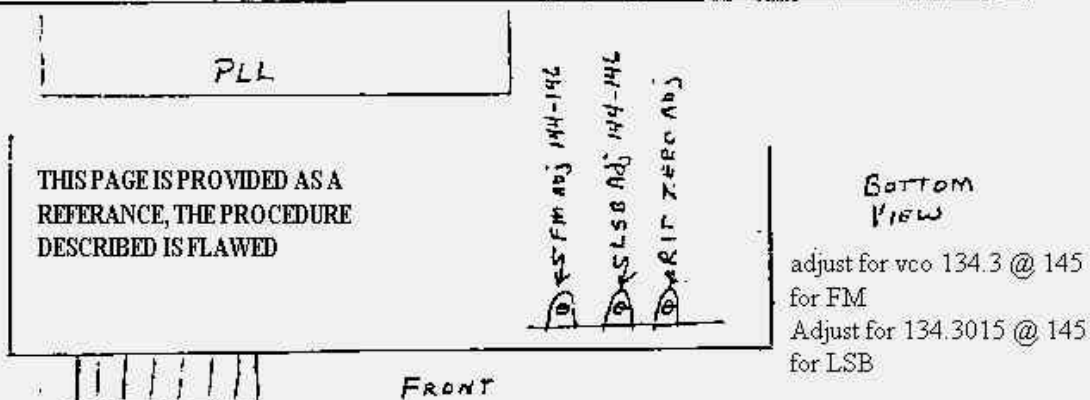
Select FM mode in the 144 - 146 range and adjust to frequency using transmit or receive mode. The FM adjustment is located behind the front panel. See diagram below. Select LSB and zero beat using the LSB adjust resistor next to the FM adjust resistor and the zero beat method used for USB. If the RIT causes a frequency shift when turned on in the center position, you may wish to adjust its zero position. Use the RIT zero adjust resistor shown in the drawing. You can adjust in FM using the discriminator meter or in SSB using the zero beat technique. This completes the PLL alignment. The radio should be reassembled.

The lockup pots control the transit time between VFO A & B in the duplex mode. A CW adjustment shortens the transit time. Too much CW rotation will cause an oscillation to occur. This control should be adjusted only when necessary and then just to the point where the transition is smooth and no "ripping" sound is heard.

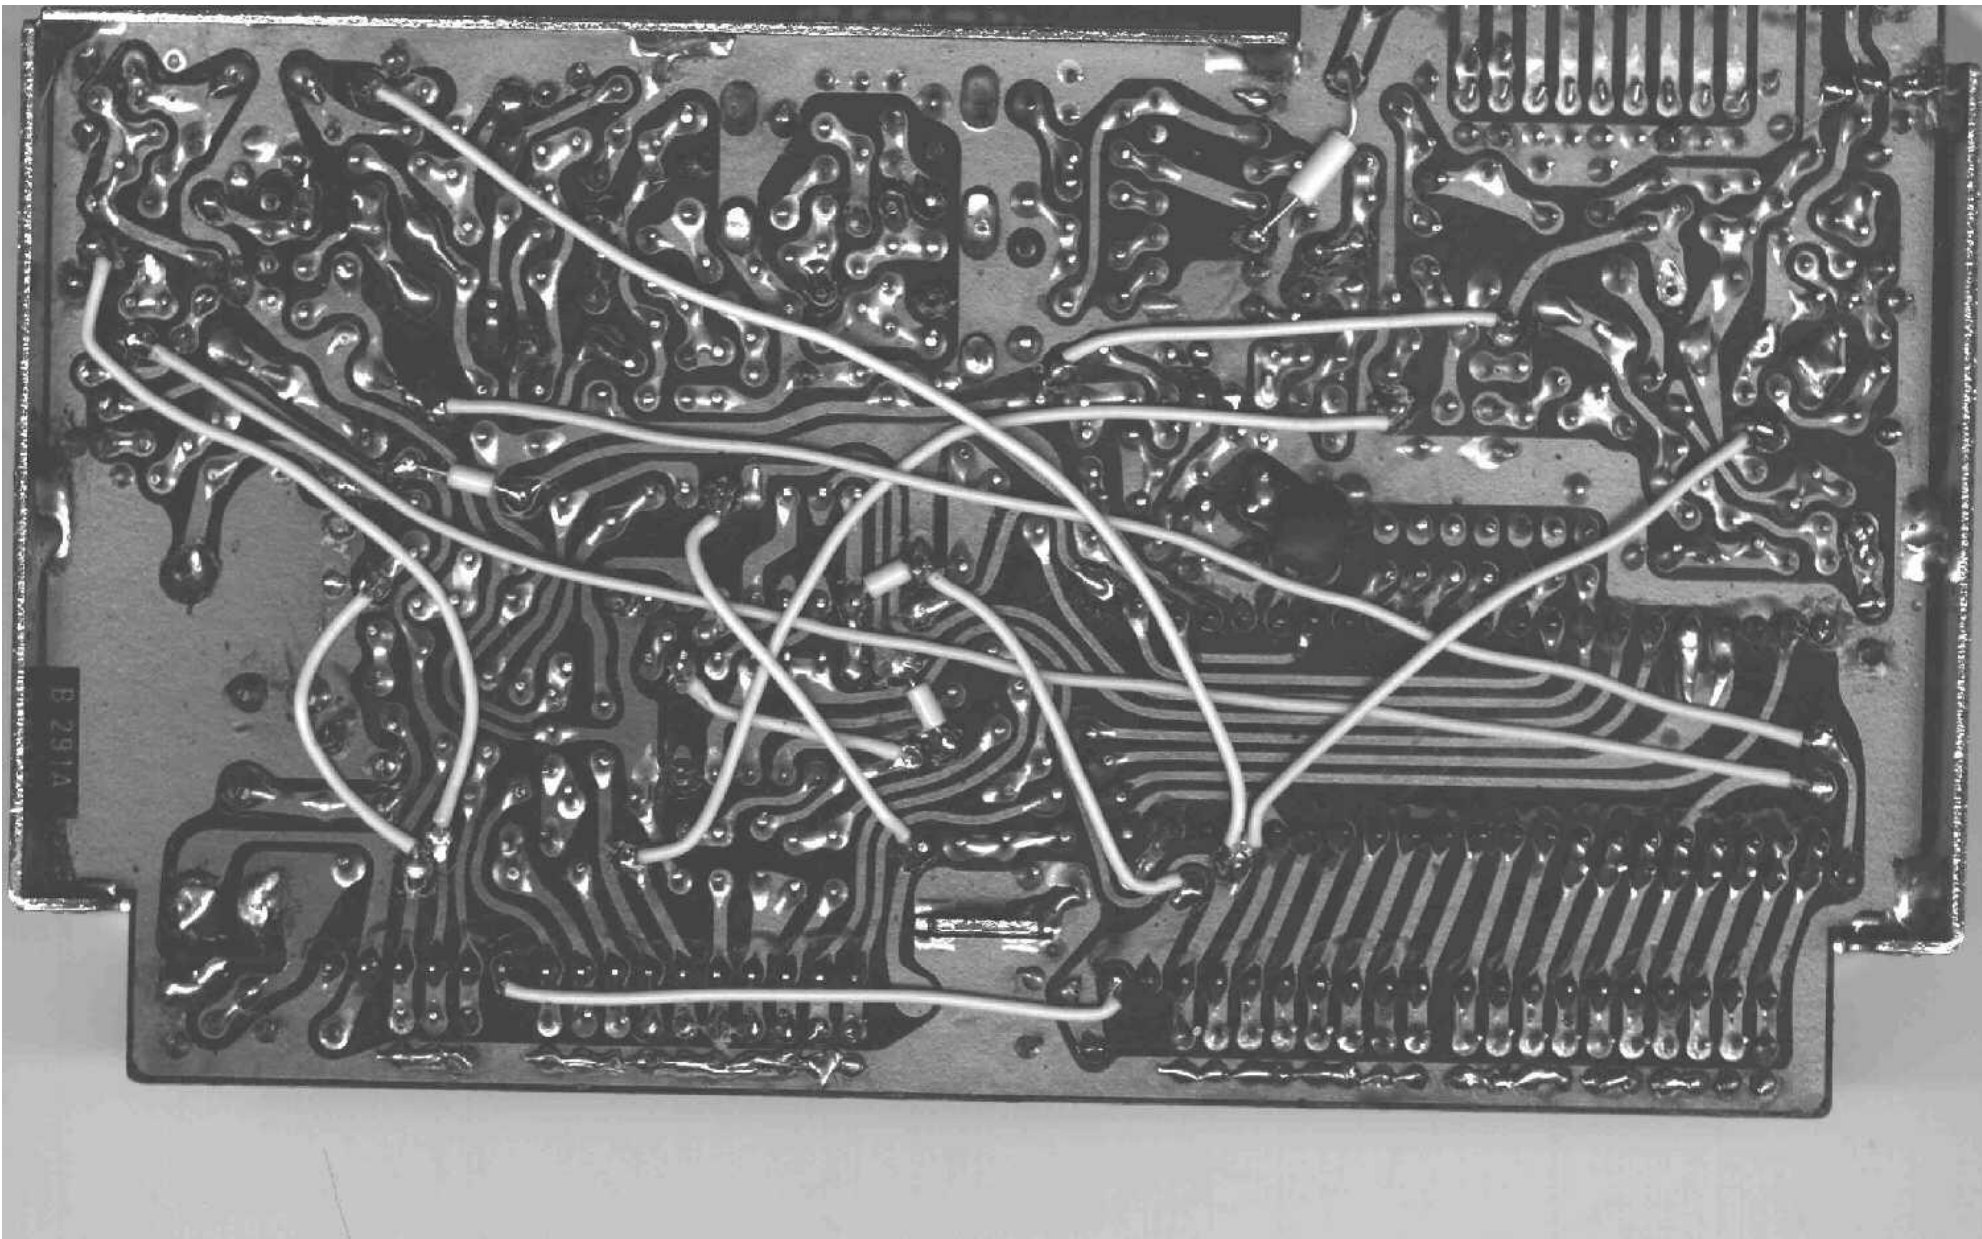
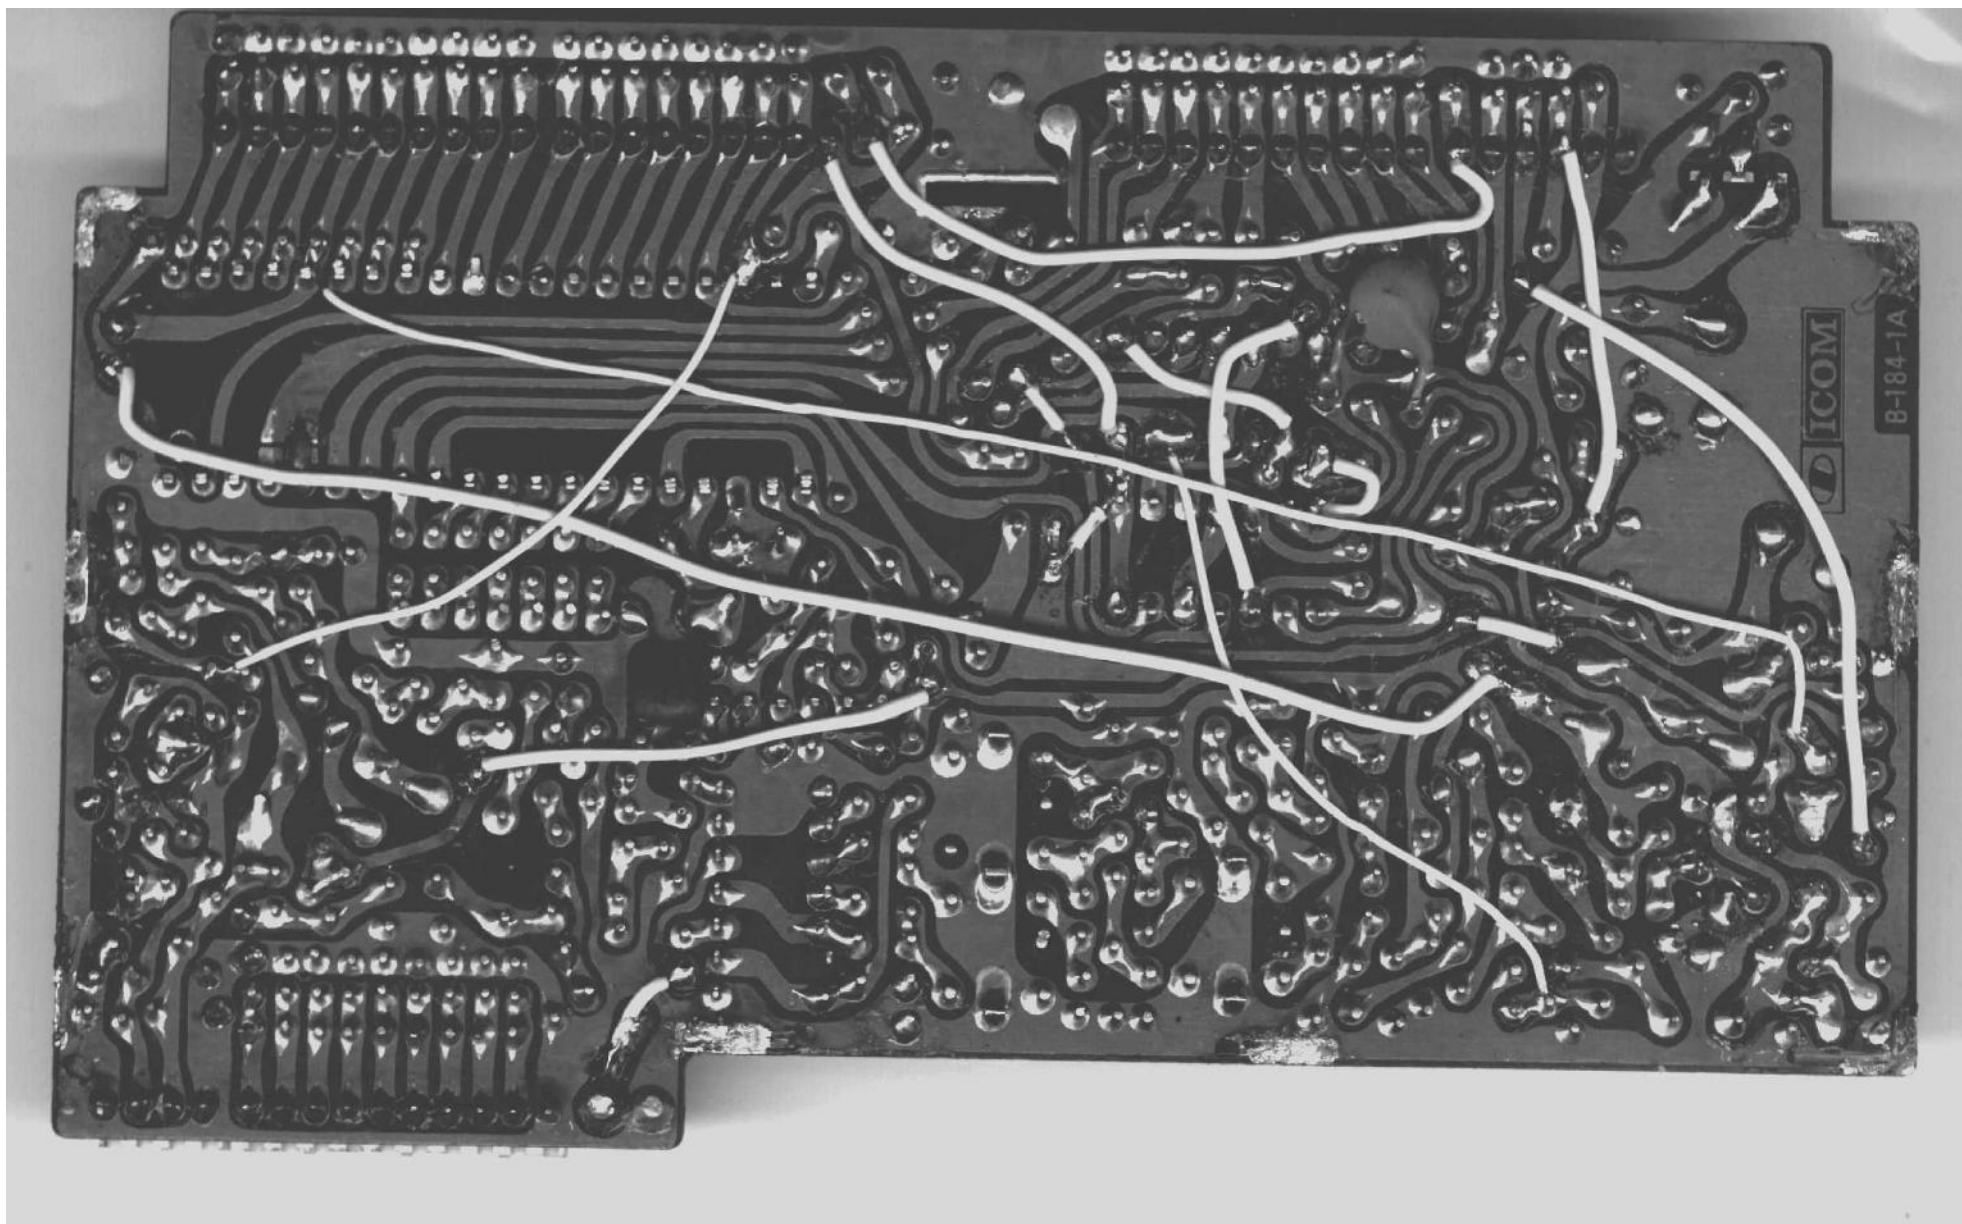
Complete frequency alignment of the synthesizer of the 211/245 requires removal of the synthesizer cover. This is accomplished by removing the retaining screws from the cover and carefully lifting the cover off. In most cases, the seals will be broken voiding warranty. Alignment should be accomplished by ICOM during the warranty period and by knowledgeable persons after that. Care must be exercised to insure minimum contact with the large scale integrated (LSI) chip. It is a CMOS device costing about \$50 and static electricity discharges can destroy it.

211 PLL Alignment: The PLL alignment is straight forward, does require a accurate frequency counter and patience. If the frequency is off by more than 4Khz, there are other problems and the alignment sheets won't help. Most common causes of problems are bad solder joints, dried out caps (electrolytics) and the -9v regulator's (DC/DC converter) associated parts. (it is very rare for the -9v reg. (DP1) to fail!). Align A, Align B
